## 异常物料停用整改 8D 报告

### Abnormal Material Outage Improvement 8D Report

供货商 Supplier Name: KOHSAN INDUSTRY CO., LTD.	料号 Material Part Number: 12122000020446 Electric Control Box Cover	品名 Material Type: 塑料类 Plastic
停用通知 编号 Outage Notice Number: MRTE20240507000724		
第一项 Step 1: Team	内部成员 Internal team members	外部成员 External members
联系人及电话 Contactor and Phone number: 086-3418373	供货商相关人员 Supplier team members: Miss.Nirada QA	客户主要相关人员 Customers team members: Miss. Hathaichanok Suthon
开始日期 Date:	08/05/2024	
第二项 Step 2: 问题叙述 Describe the Problem		日期 Date: 2024/05/08
<p>周期检验：外边缺陷不合格，其他项目不做测试。外观缺陷（弯曲变形）：异常项目：外边缺陷 异常描述：电控盒盖按键变形，抽检（80；5，6，）不合格 10 件，不良比例 12.5 %；</p>  		
第三项 Step 3: 叙述产生原因 Reason(root cause) Analysis		日期 Date: 2024/05/08
<p>‘- New injection worker not well trianed.</p> <p>‘- Current marking method ineffective and can result in visual failure.</p>		
第四项 Step 4: 问题抑制方案 Implement containment actions (corrective measures)		日期 Date: 2024/05/08
<p>‘- Recheck stock return from Midea 100% with yellow mark confirm 5,400 ea OK 5,274 ea / NG 126 ea→ NG scrap</p> <p>‘- Recheck stock at Kohsan 100% with yellow mark confirm 4,800 ea OK 4,756/ NG 44 ea→ NG Scrap</p>

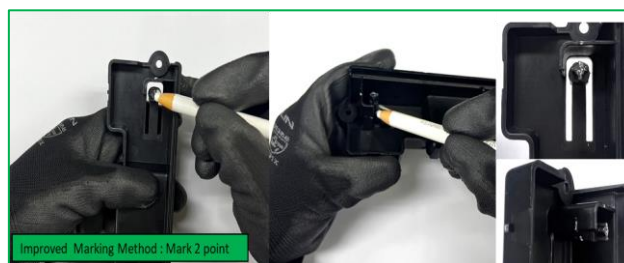
After retraining injection worker and change marking method, not found NG

- Change marking method to increase efficiency in visual inspection.
